Micro-characterisation of haze and degradation on zinc white oil-based painting, Portrait of a Peranakan gentleman Mr Tan Beng Wan, Singapore

Lynn Chua¹, Irene Dominguez¹

¹ Heritage Conservation Centre, National Heritage Board, Singapore

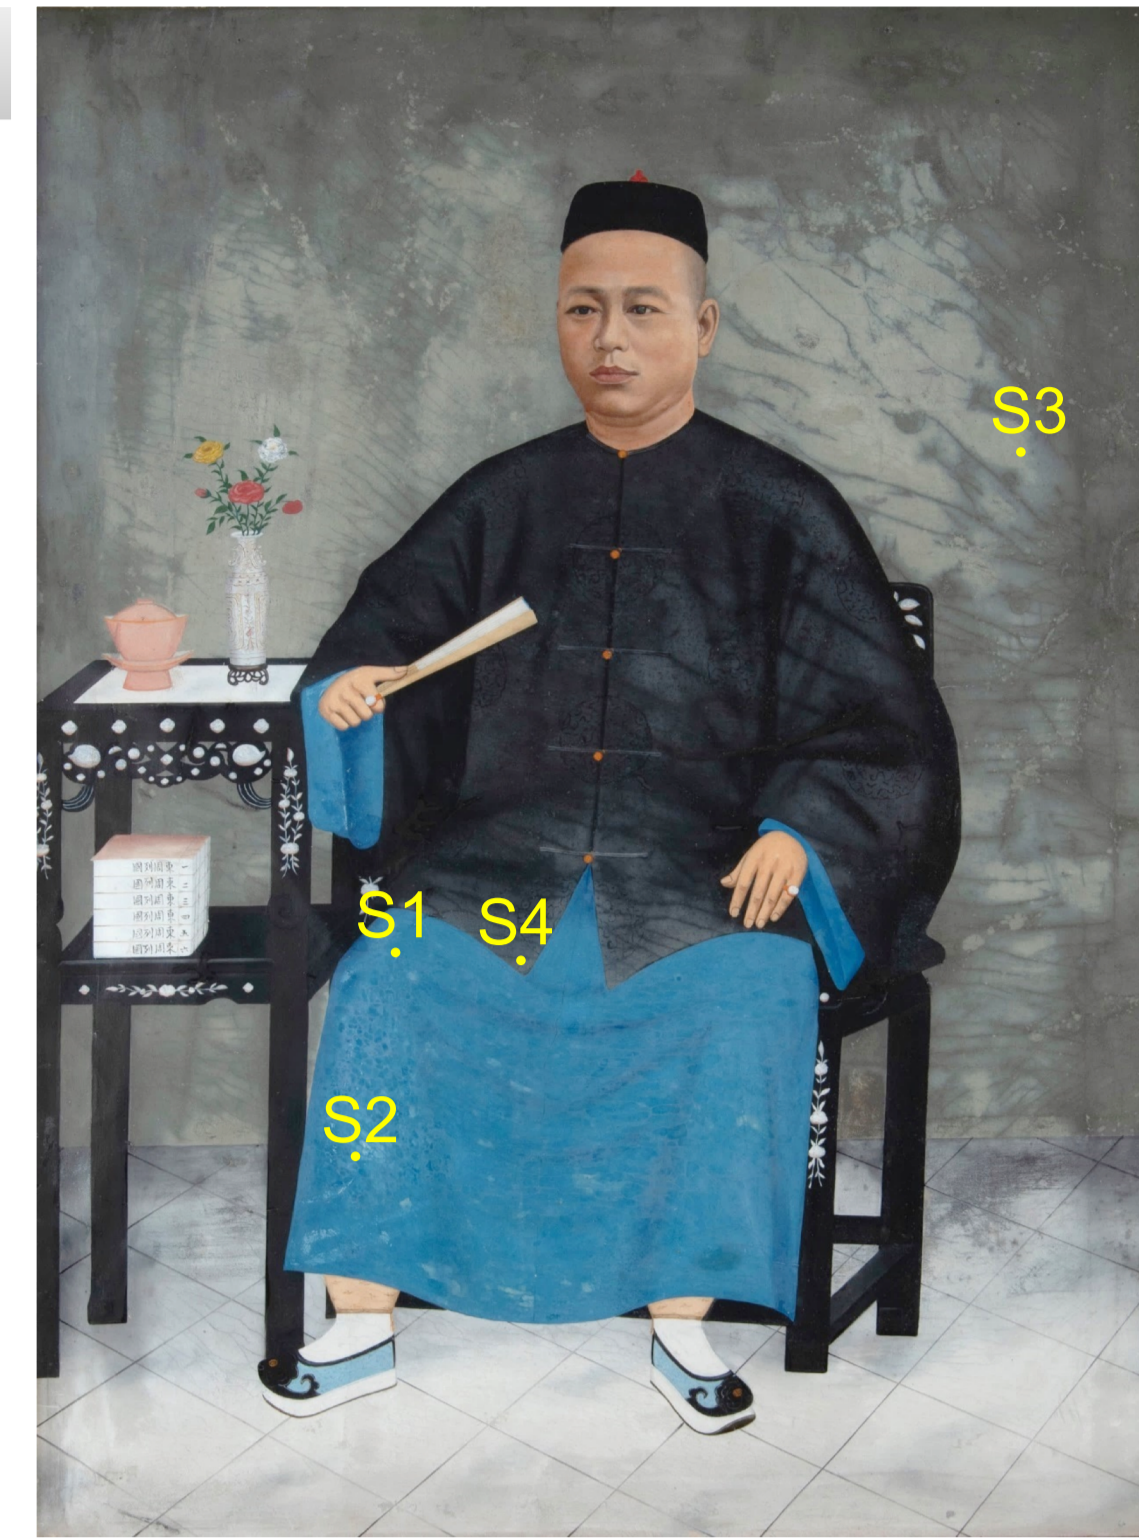
The haze appeared wide-spread in the dark grey background of the portrait, occurring along selected areas of the blue gown (*chang pao*) and the black jacket (*ma gua*). Craquelure was present throughout the entire surface of the painting as well as paint losses, holes and abrasions were evident. Visually, it was difficult to ascertain if the whitish haze formed in some areas was part of the artist's intention or due to the intrinsic degradation of paint, which would be important information to the conservator's decision in their removal. Preliminary cleaning tests showed that the haze is generally not removable with water swabs. Although mechanical removal alone was possible, it had the risk of damaging the paint layers and was not recommended. More investigation of the haze was deemed necessary to support the conservation treatment.

"Portrait of Mr Tan Beng Wan"
Late 19th century to early 20th century,
Collection of The Peranakan Museum

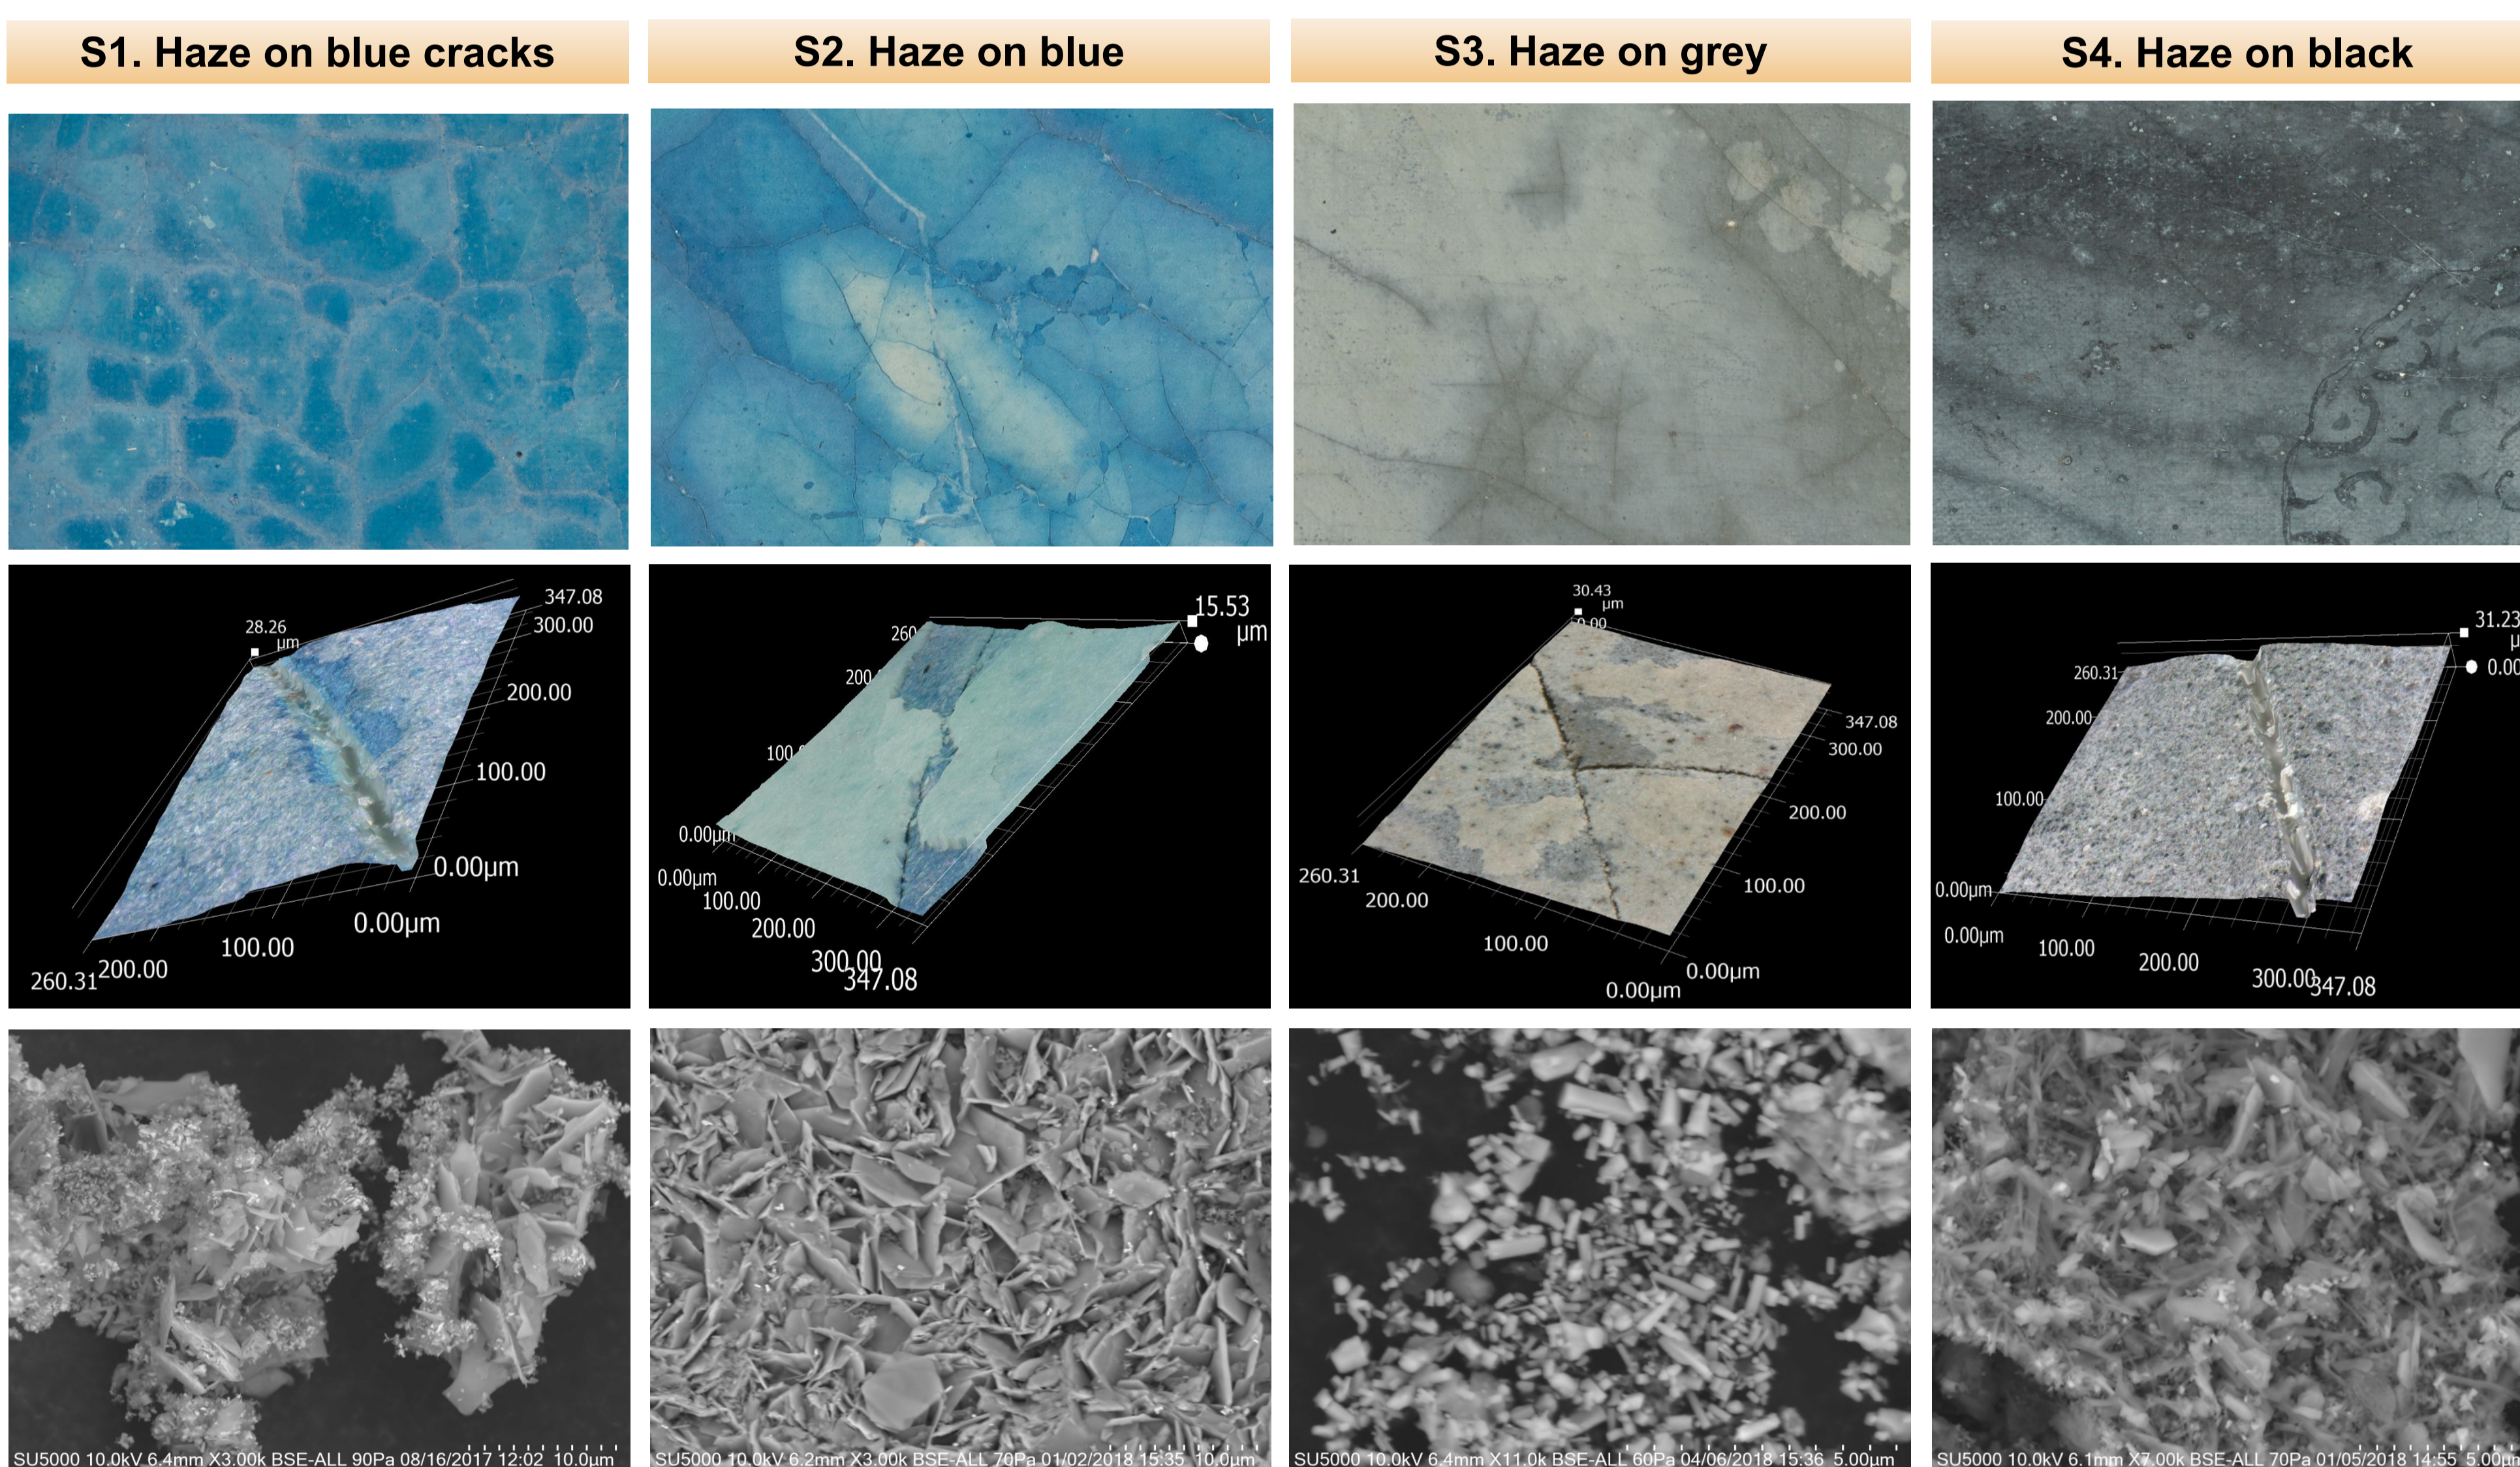
Images of various whitish haze S1-S4- Top tier: 2D visible light images; Middle tier: 3D images at magnification 1000X; and Bottom tier: SEM images at magnifications 3000X (S1), 3000X (S2), 11,000X (S3) and 7,000X (S4)

The haze and painted layers were so thin that it was difficult to understand the layering with 2D images. 3D images showed that the conformation of the haze was thinly formed on the paint surface, within 6 μm thickness. SEM images showed the morphology of the haze taking the shapes of polygonal platelet structures, rod-like and needle-like structures, suggesting crystalline growth.

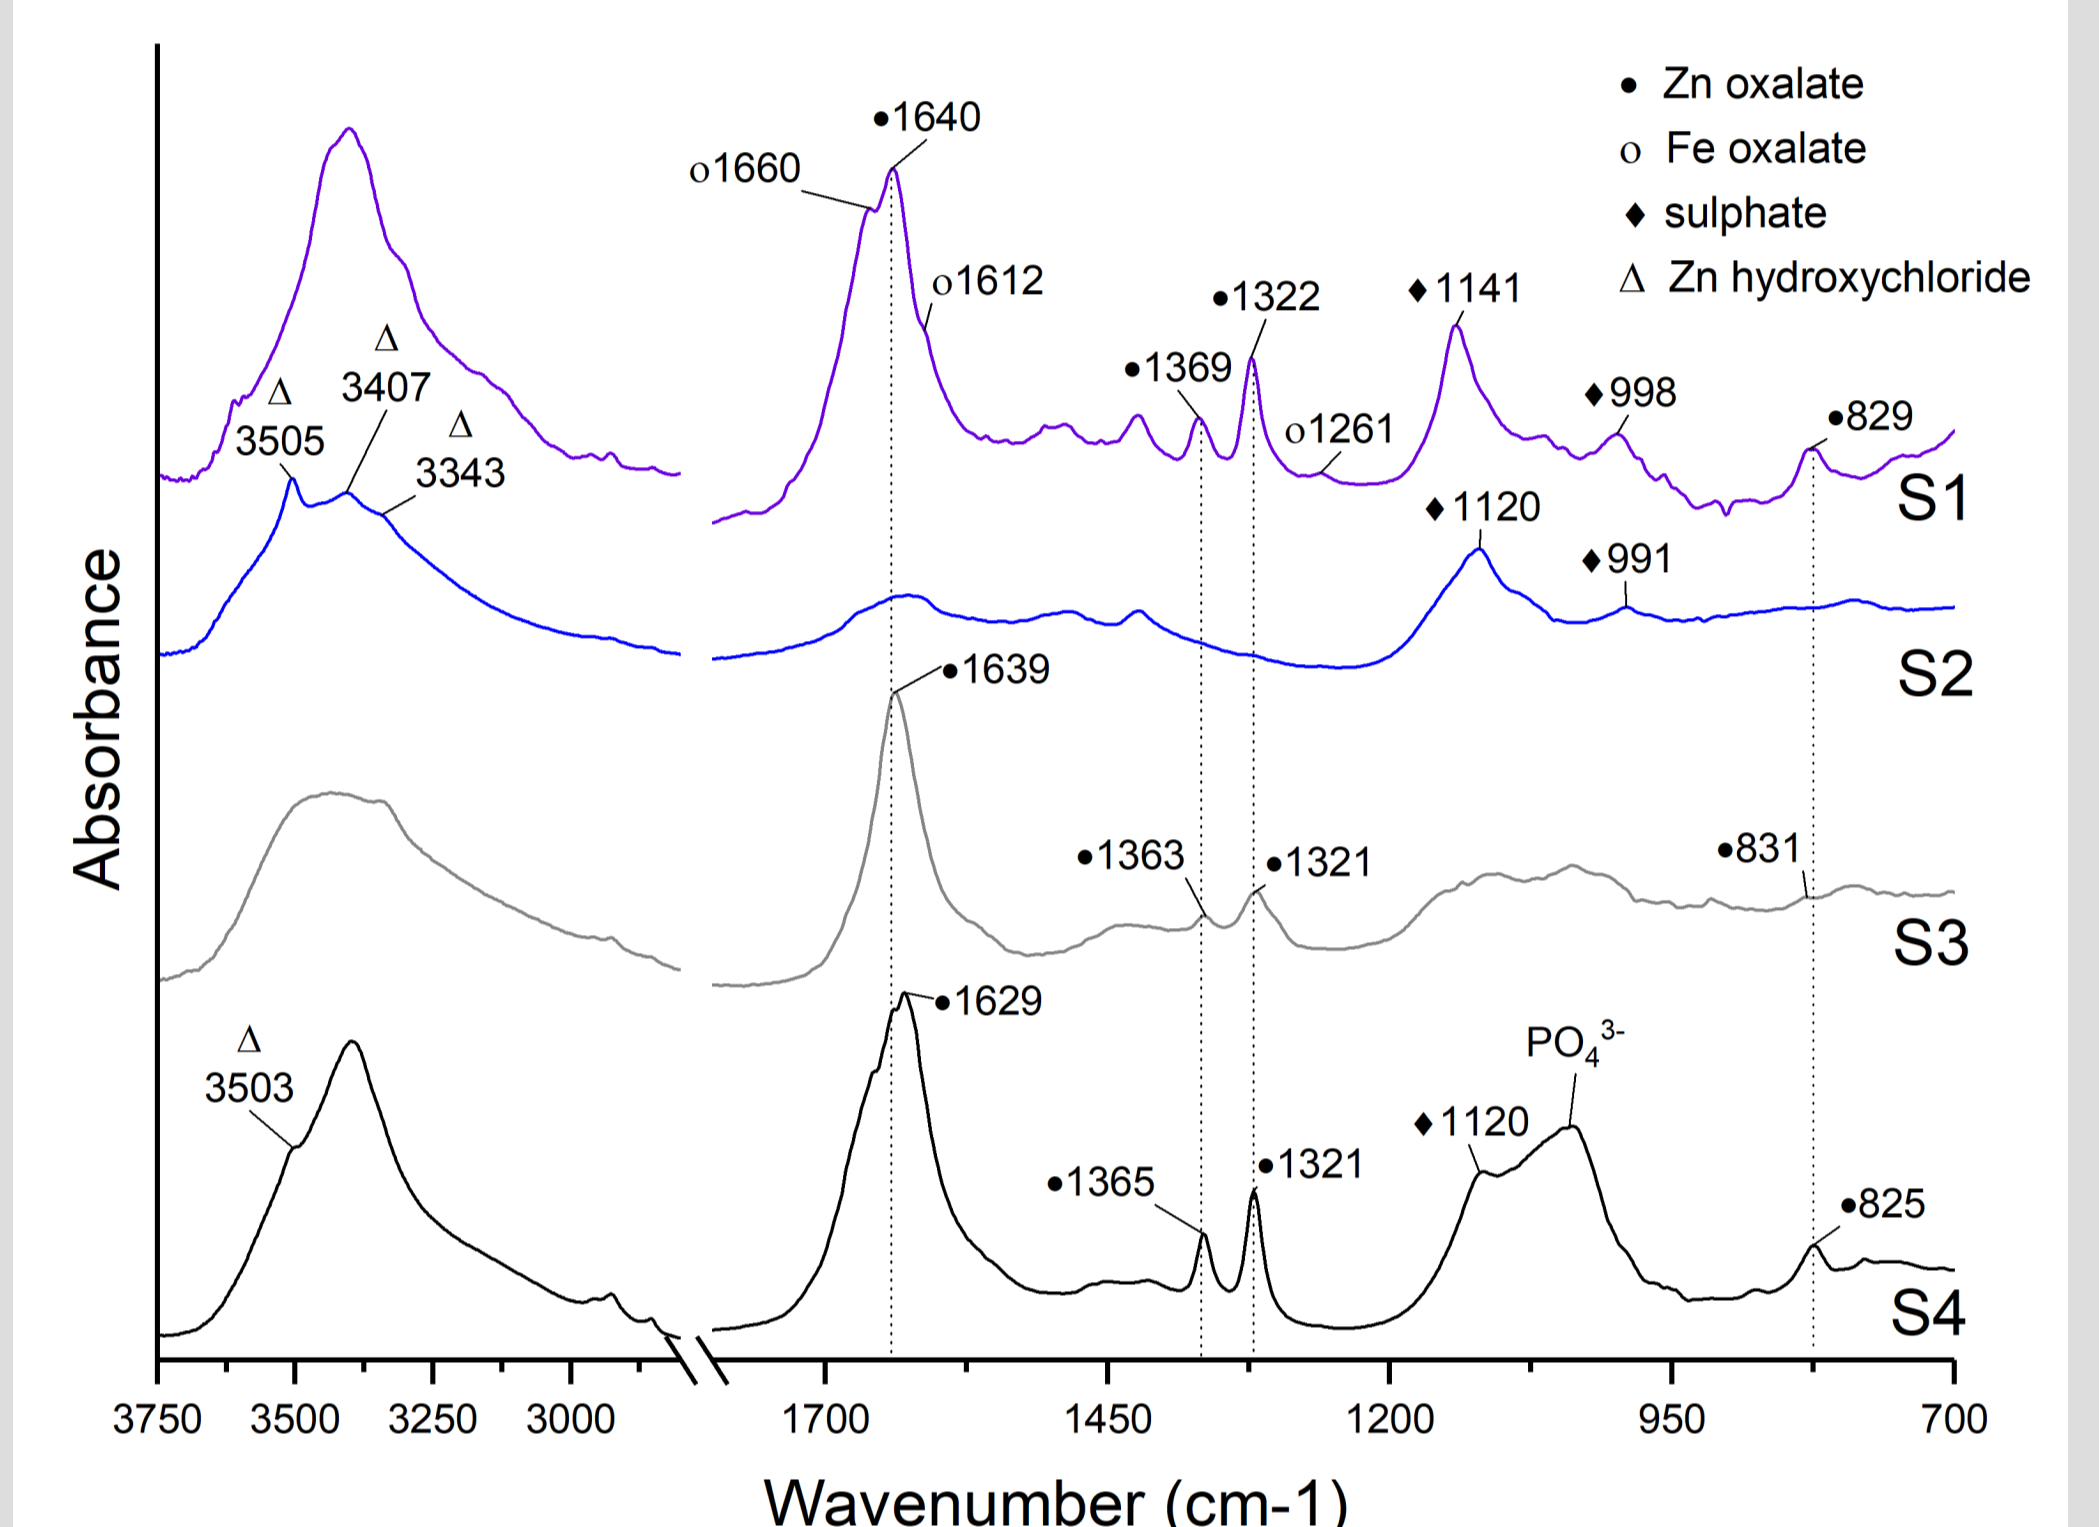
FTIR spectra of four micro-areas of haze: S1- Zn oxalate, sulphate and Fe oxalate; S2- Zn hydroxychlorides (possibly simonkolleite), sulphate; S3- Zn oxalate; S4- Zn oxalate, Zn hydroxychloride (possibly simonkolleite), sulphates

FTIR and SEM-EDS results showed that the haze formed on the paint matrix (oil-based binder containing zinc white, Prussian blue, bone black) was mainly composed of zinc-related efflorescence containing hydroxychlorides, sulphates and oxalates.

- The results suggests that the haze was due to intrinsic degradation of the painting and not intended by the artist.
- The formation of hydroxychlorides and sulphates is likely due to migration of zinc soaps from the ground and the paint layers, which subsequently interacted at the paint surface with the environment (e.g. dirt, pollution) [3]. The source of oxalates was postulated to arise from oxidative degradation of the organic binder or resinous coating to oxalic acid, catalyzed by the zinc white pigment [3, 4].
- For future conservation work, the removal of the haze using different cleaning systems such as chelating agents shall be investigated.

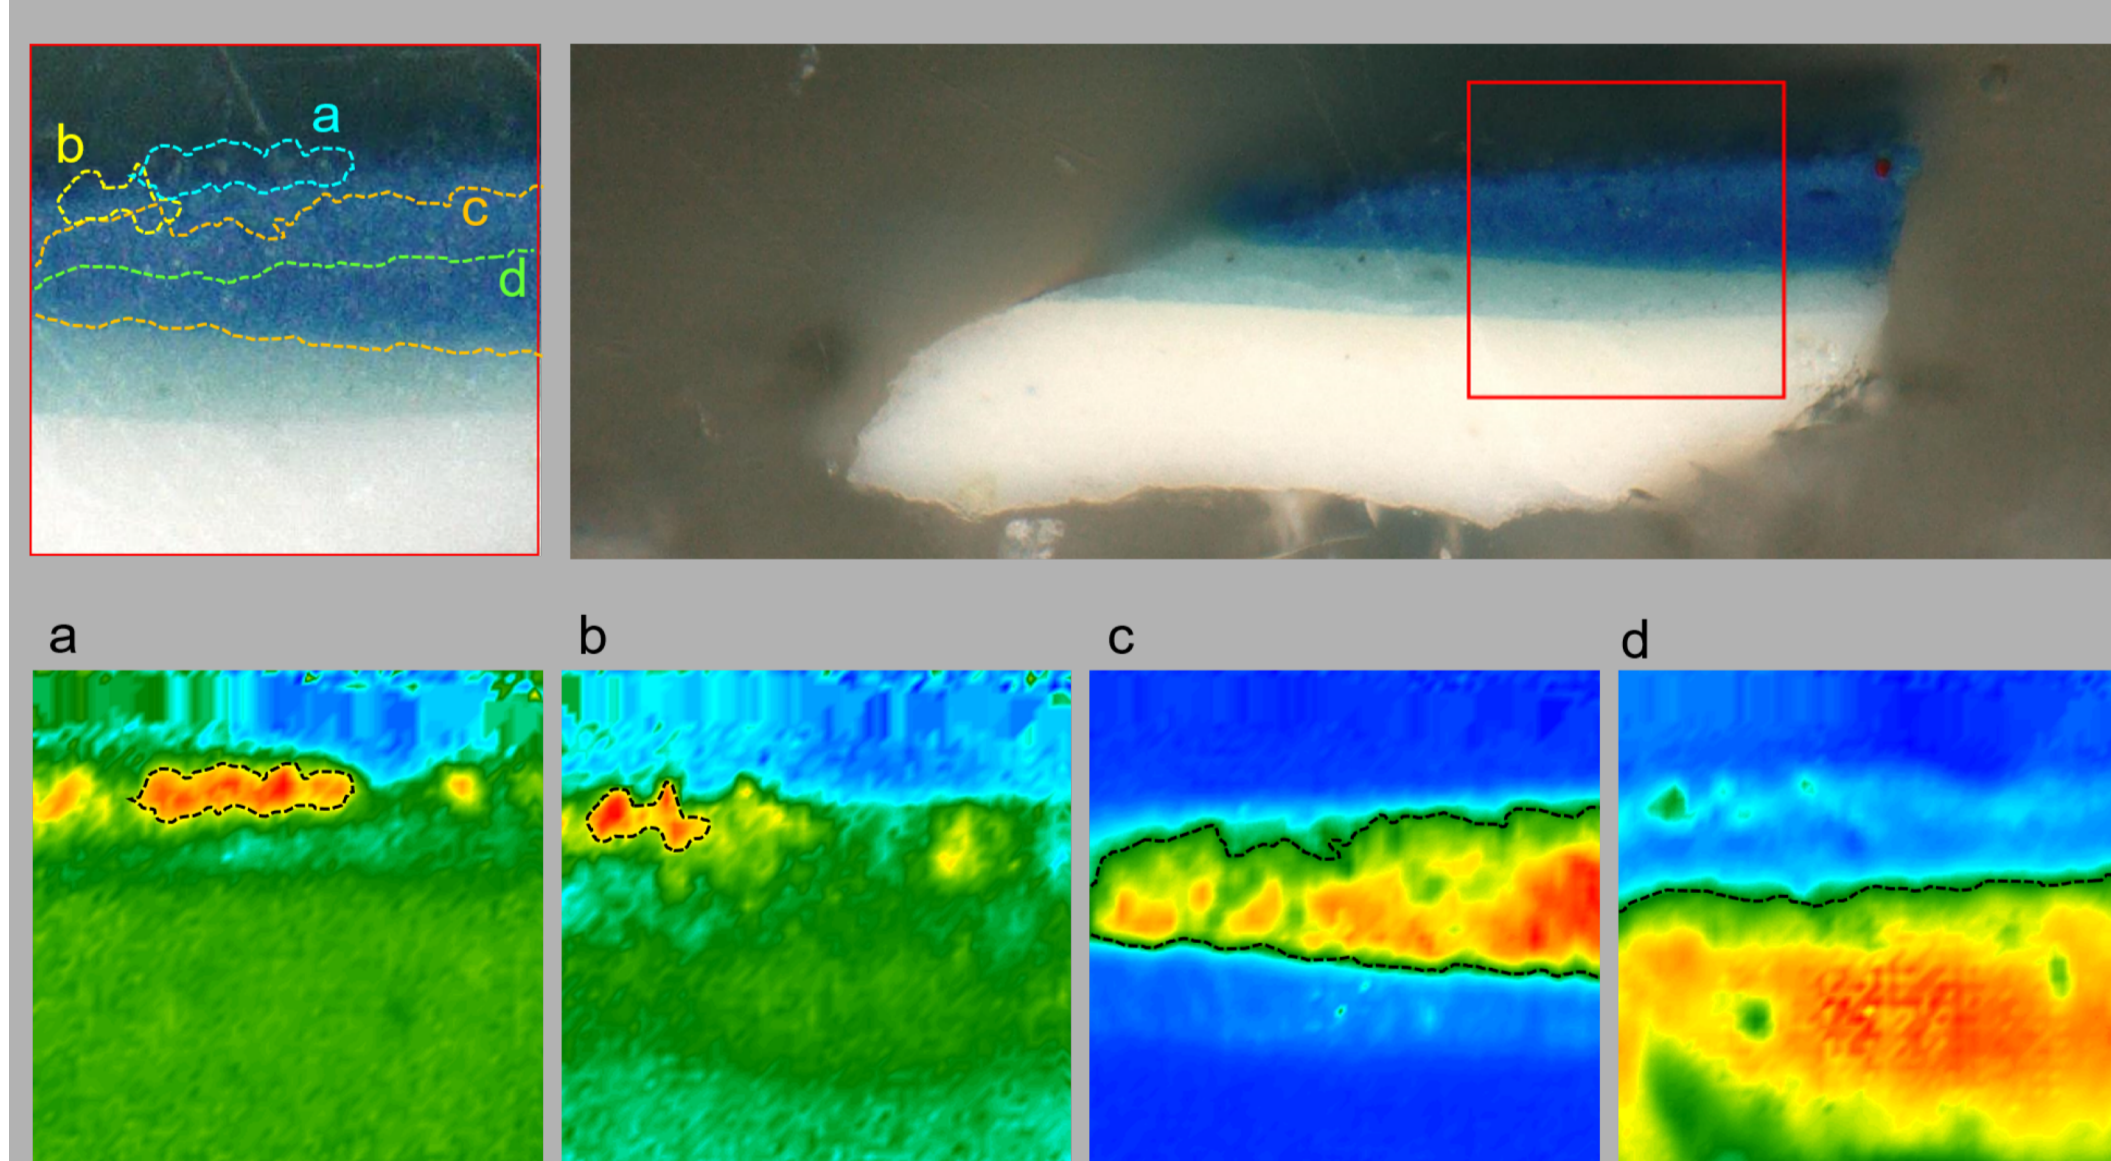
FPA-FTIR images (70 x 70 μm) of cross-section from haze on blue cracks (S1) with integrated absorbance: a – (1114 cm^{-1}) zinc hydroxychlorides, sulphates; b – (1320 cm^{-1}) zinc oxalates; c – (2088 cm^{-1}) Prussian blue; and d – (1564 cm^{-1}) zinc soaps.

The SEM image of cross-section 1 showed that the thin haze (about 2-6 μm thickness) was formed on the surface of the blue paint and aggregates were present in the paint layers and the zinc white ground. From the FPA-FTIR images, these aggregates were identified as zinc soaps (d), whereas the occurrences of zinc oxalates (b) and zinc hydroxychlorides, sulphates (a) were localised at the paint surface.
